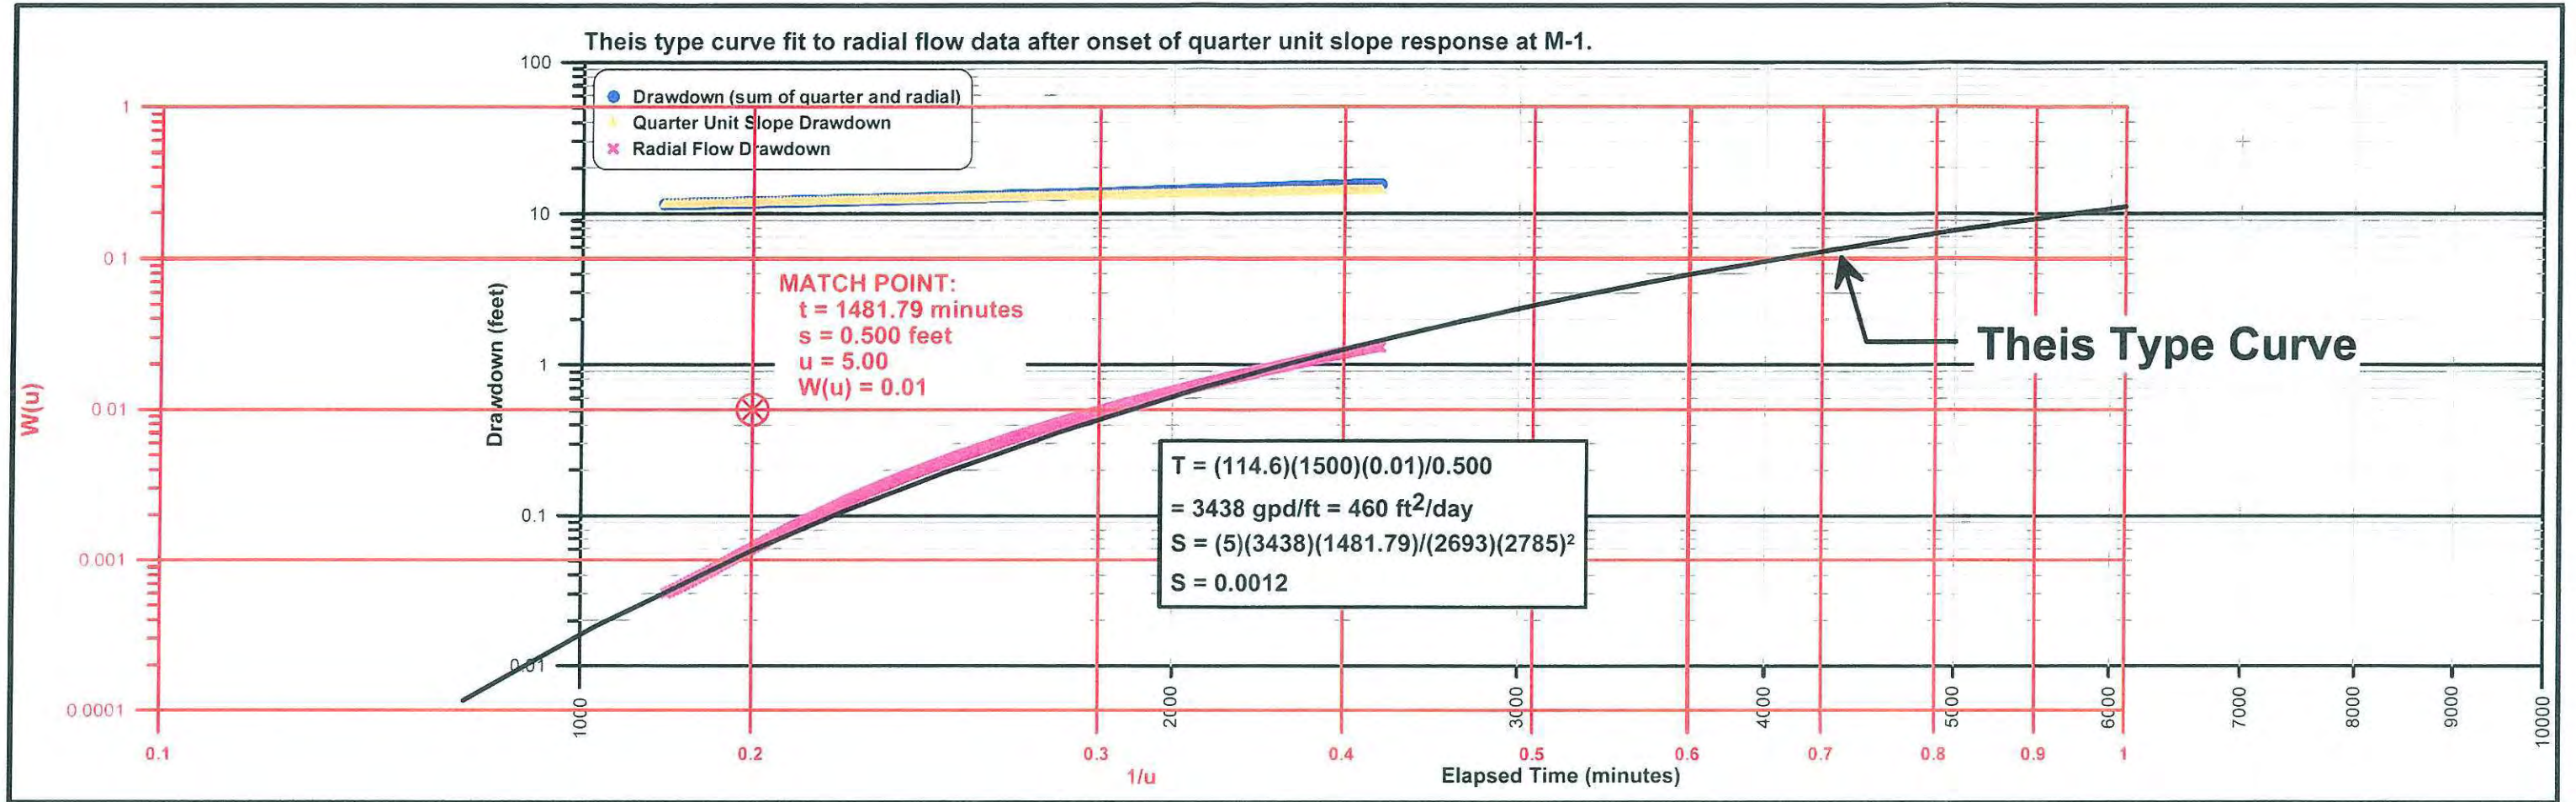
Figure 45: Theis solution for transmissivity and storativity from well M-1 drawdown.

aquifer storativity value of  $1.2 \times 10^{-3}$  is dependent on the transmissivity value determined at well M-1.

Both of the transmissivity values substituted into the storativity calculation provide the same result when rounded to  $10^{-3}$ . This, plus the fact that the transmissivity value derived by separating drawdown components at well M-1 is in good agreement with that derived from the pumped well data, lends support to the conclusion that the aquifer storativity is genuinely in the order of  $10^{-3}$  and that reinterpretation of the data with aquifer test software is unlikely to change that conclusion. Aquifer test software is not designed to make the separation between linear flow drawdown and radial flow drawdown that must be made before the aquifer test response at well M-1 can be interpreted. Therefore, any application of aquifer test software to interpret the M-1 time-drawdown response without pre-processing the data as shown herein will yield erroneous and misleading results.

It should also be noted from Figure 45 that projection of drawdown at well M-1 based on the Theis type curve appears to overestimate drawdown when compared to the radial flow curve separated out of the total observed drawdown. Therefore, the projection of radial flow drawdown shown on Figure 43, is conservatively large.
